The 30 November 2018 M_w 7.1 Anchorage Earthquake

by Michael E. West, Adrian Bender, Matthew Gardine, Lea Gardine, Kara Gately, Peter Haeussler, Wael Hassan, Franz Meyer, Cole Richards, Natalia Ruppert, Carl Tape, John Thornley, and Rob Witter

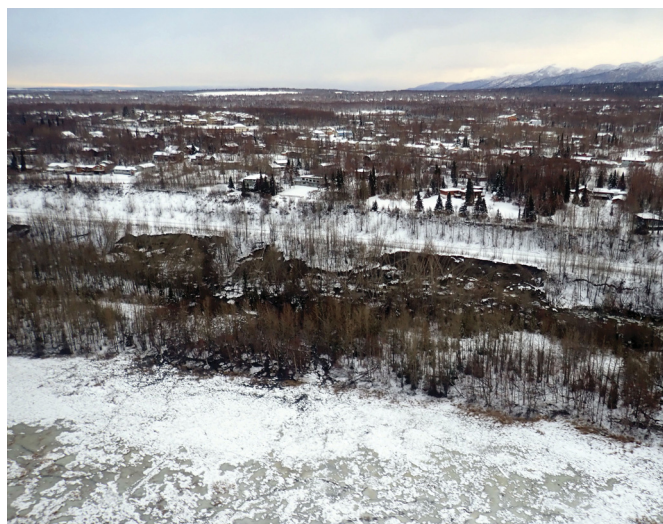
▲ **Figure 8.** Complex slumping along the Alaska Railroad overlooking the tidal flats of Turnagain Arm, looking northward. Failure of these low bluffs, known as Potter Hill slides (Hansen, 1965), occurred previously during the 1964 Great Alaska earthquake and again during an earthquake in 1954. (61.0874°, -149.84214°). Photo: Adrian Bender.

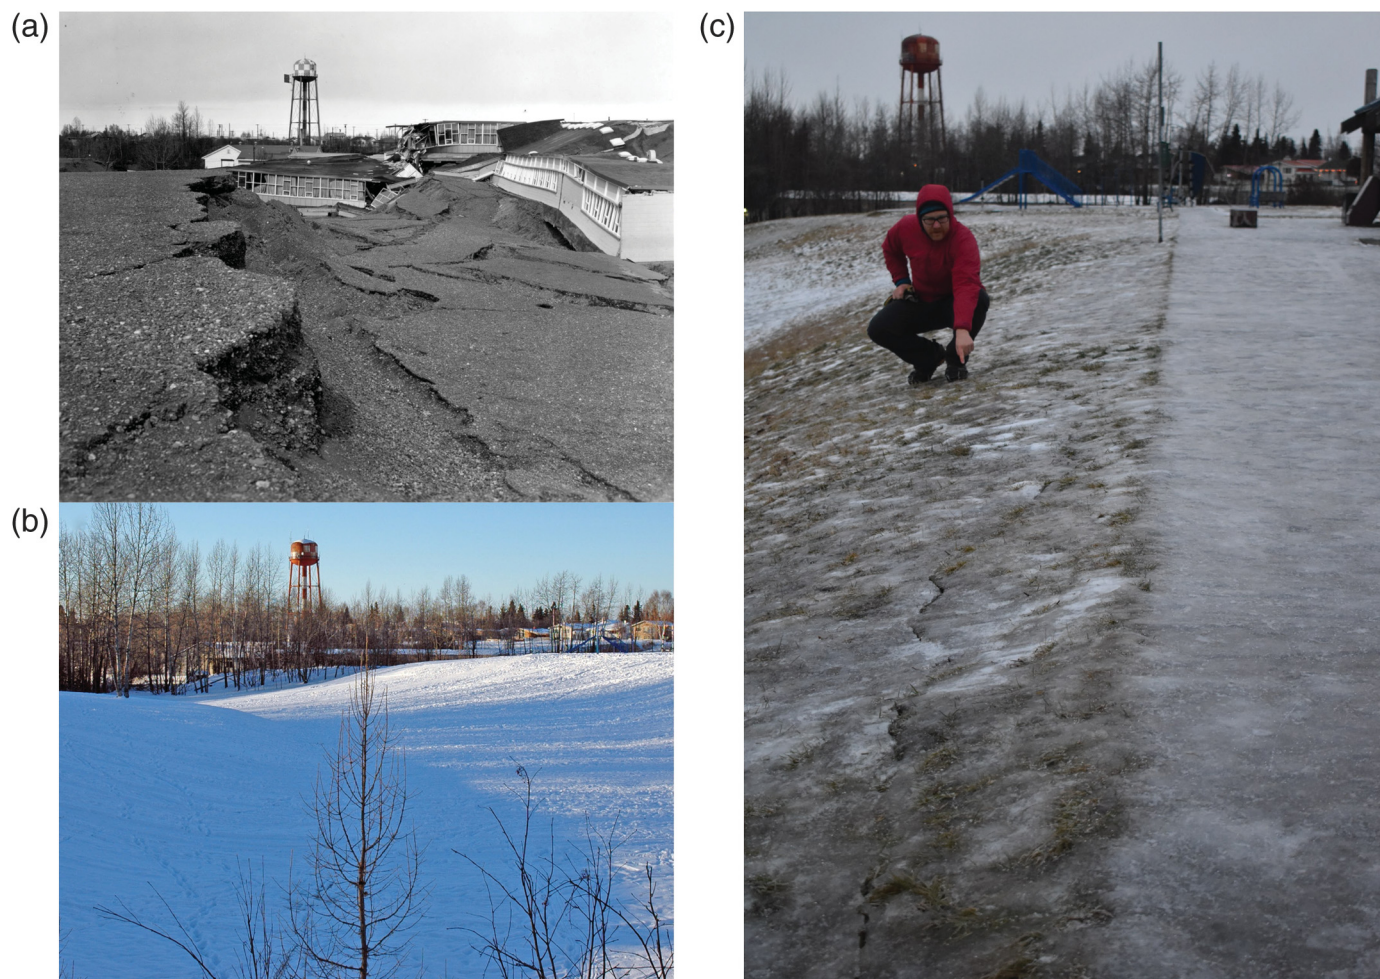
▲ **Figure 9.** Comparison of ground failure relative to 1964. (a) View to the west showing the Government Hill School collapsed into a graben, or linear trough, formed by the Government Hill landslide in 1964 (Hansen, 1965). (b) Same view in 2013. The graben formed by the landslide is still expressed in the landscape in the lower photo. Photo: Game McGimsey. (c) Crack along headscarp of 1964 slide observed on 4 December 2018. Photo: Rob Witter.

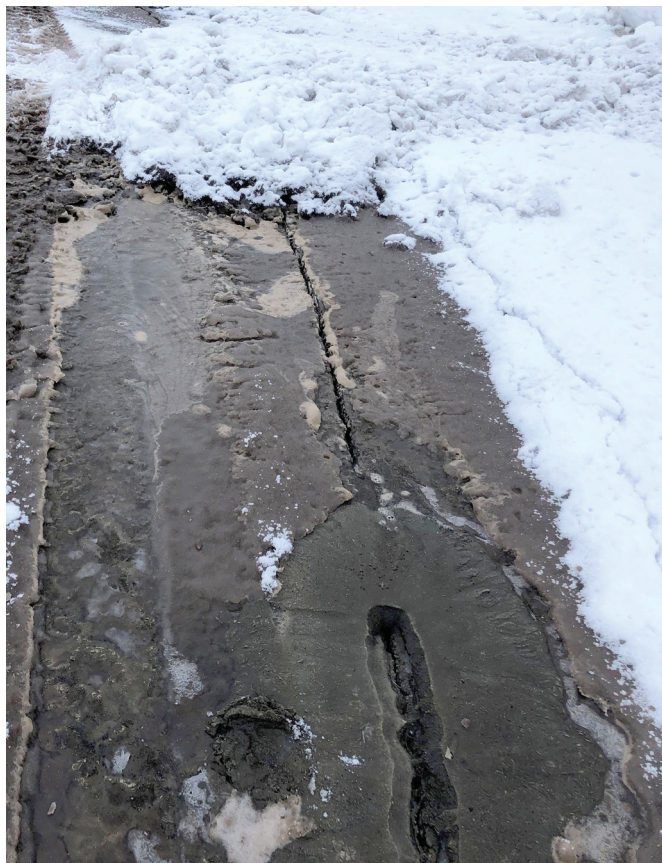
▲ **Figure 10.** Sand boil, about one foot in length, along a sidewalk in south Anchorage. Photo: Howard Weston.

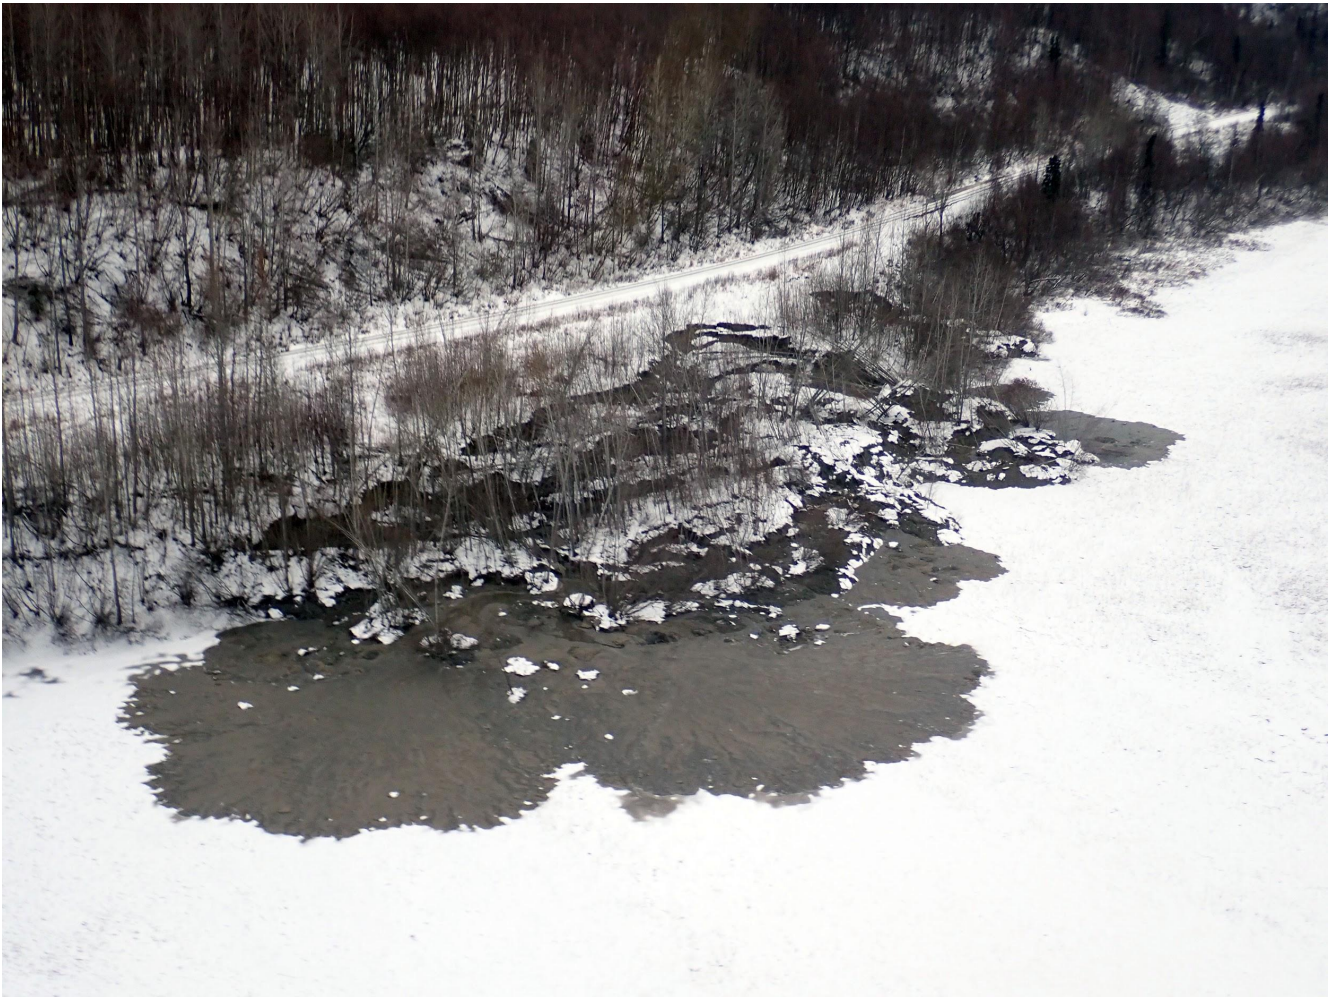
Figure S10.

Lateral spreading disrupted Vine Road near the town of Wasilla in this view looking north. Many failures of engineered materials occurred on or adjacent to saturated lowlands filled with organic sediment, silt, or sand. (61.4376°, -149.4496°) Photo: Marc Lester.

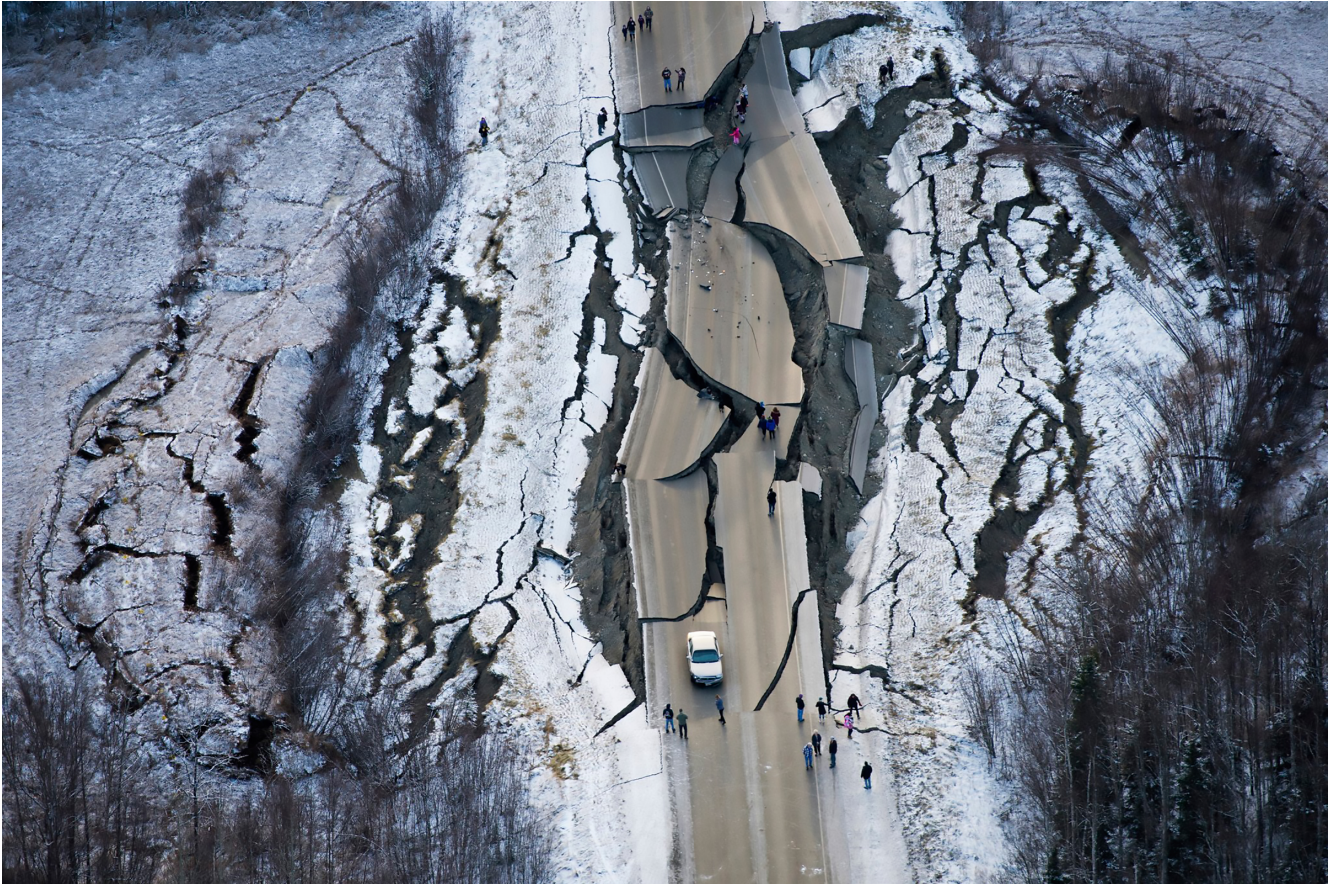
Figure S11.

House built on anthropogenic fill. Significant ground cracks and settling are present. Variable settling is indicated well by the tilted rooflines and gap between the structures. The sloped driveway demonstrates how, in this neighborhood, a large volume of soil was used to elevate structures above street level. Settling in these types of soils was one of the primary drivers of residential damage. (61.1380°, -149.9379°) Photo: Michael West.

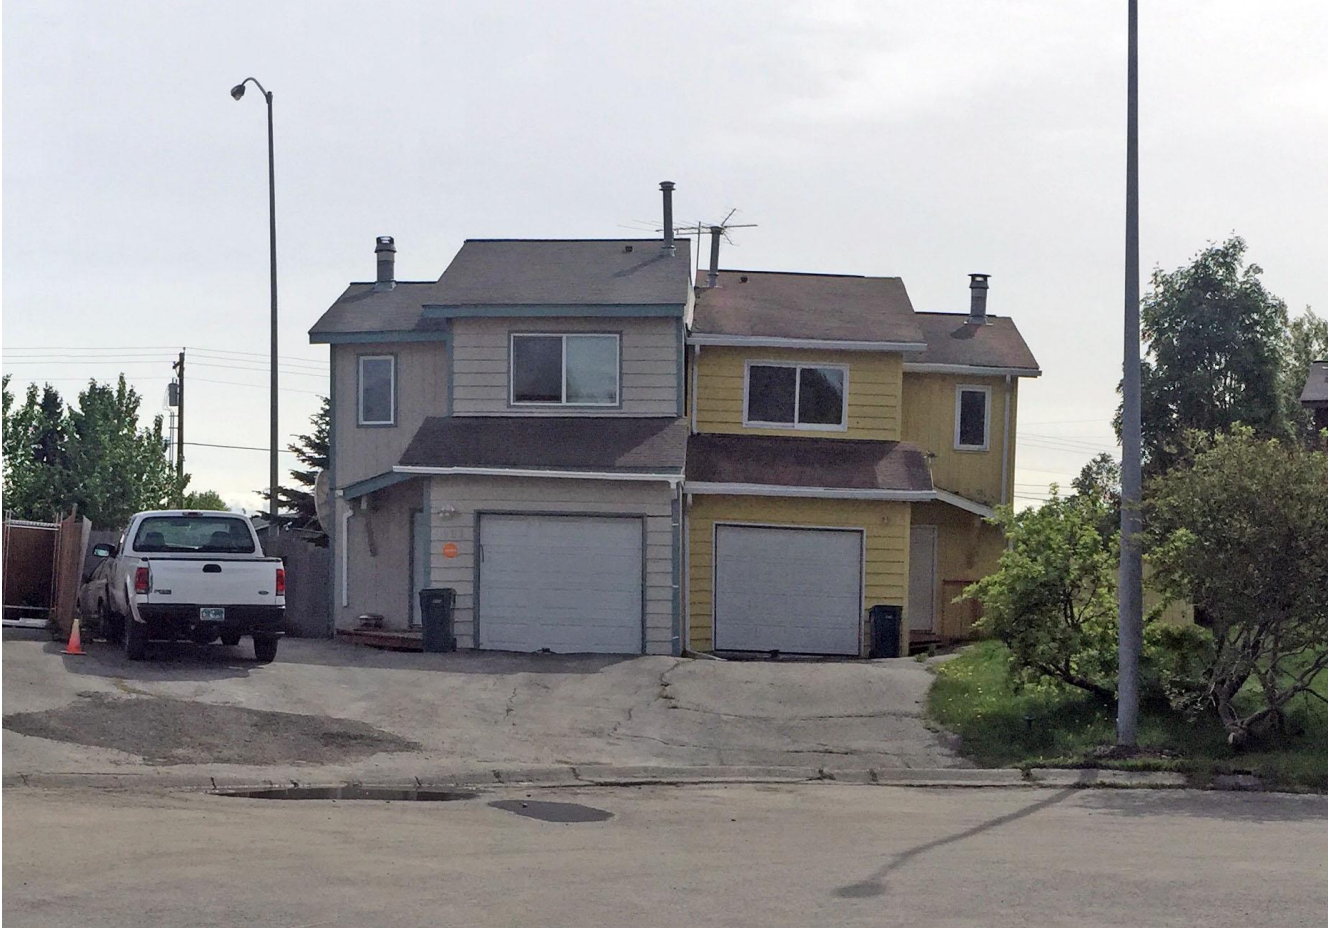
Figure S12.

House built partly on fill materials. The foundation of the house was compromised when soils settled and moved away from the structure. Photo: Loren Holmes.

fill soils moved away from structures, causing foundations to settle and crack (© Fig. S12). In areas where structural fill had been placed and properly compacted, little to no displacement was observed. As reconstruction efforts continue, one hypothesis that appears to be true is that the fill slopes that exhibited the largest displacements were constructed with poor-quality fill, were inadequately compacted or poorly designed, or were associated with a combination of factors. A thorough cataloging of observed geotechnical failures can be found in Franke *et al.* (2019).

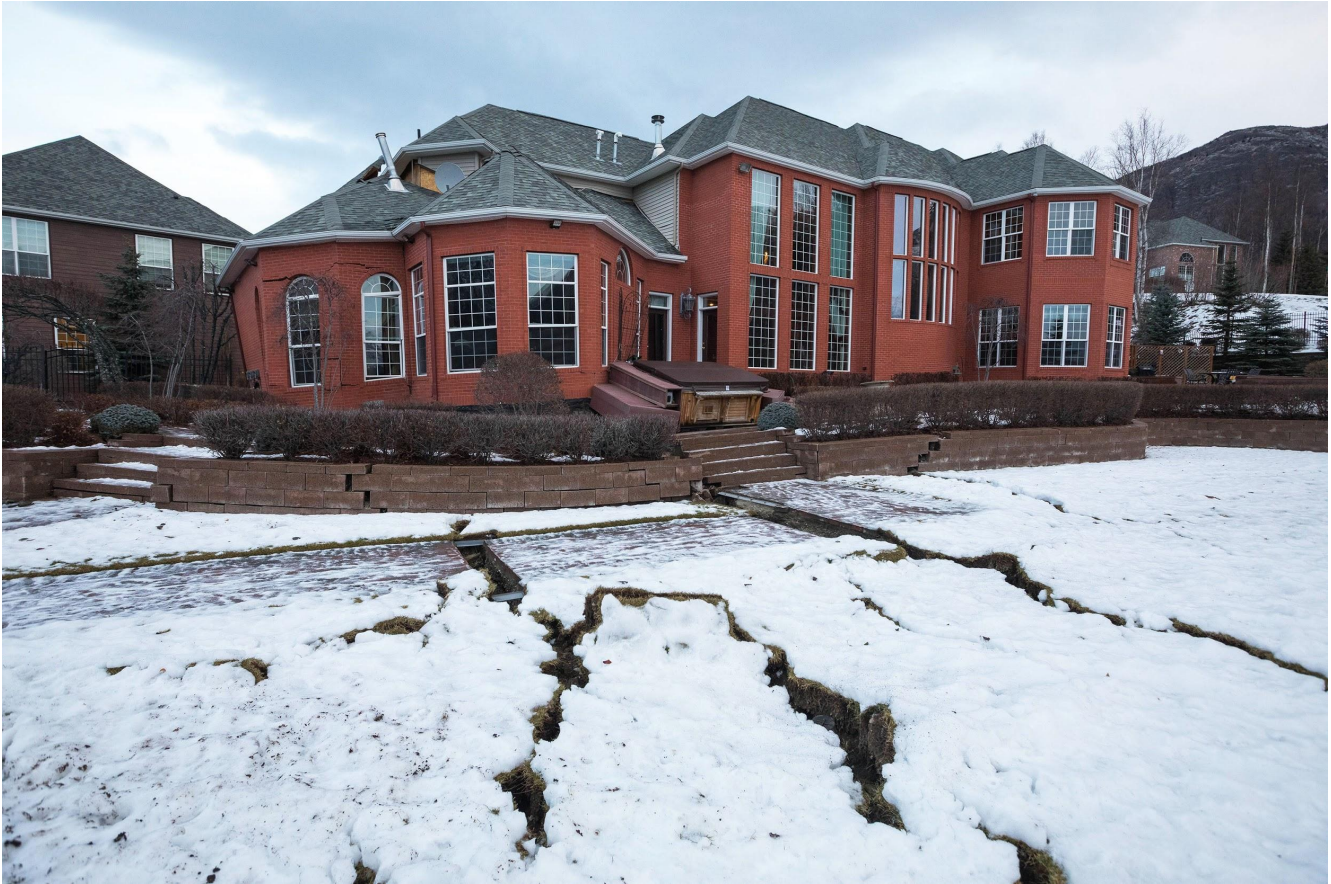
Figure S13.

Comparison of building damage and ground motion in the vicinity of Eagle River and Chugiak, north of downtown Anchorage. (Left) Original inspection placard value. Source: Municipality of Anchorage Geographic Data and Information Center. Last retrieved: April 26, 2018. (Right) Observed PGA ground motions supplemented with PGA values inferred from DYFI reports.
